Low-Cost Shore Protection

Final Report on the Shoreline Erosion Control
Demonstration Program (Section 54)
1981

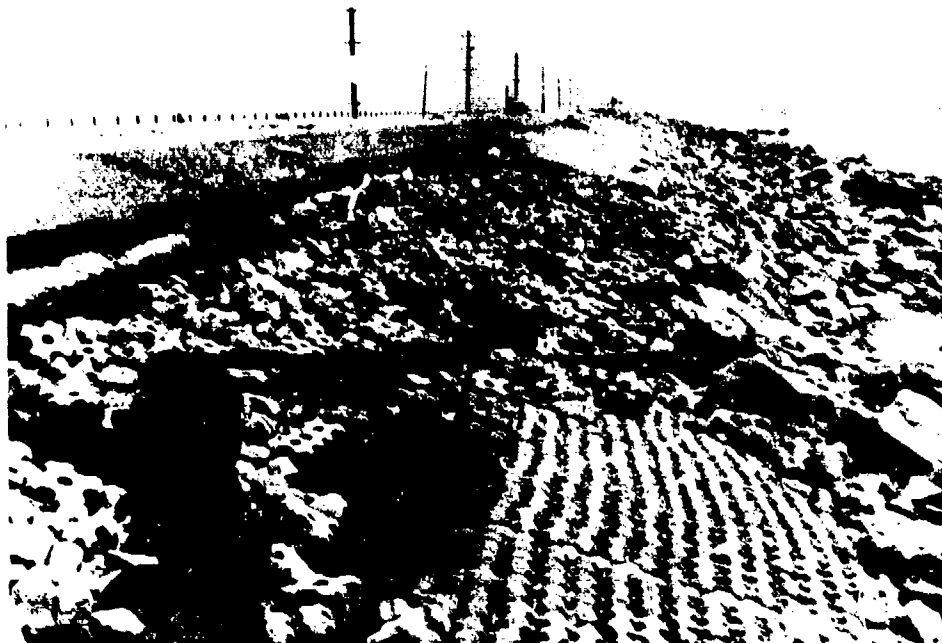
At Holly Beach, Gobi blocks were first hand-placed by the Louisiana Department of Highways in a test revetment section. Two types of filter cloth were used--one with mesh openings just larger than the median grain size of the embankment material, and the other with mesh openings over twice the median grain size. The revetment on filter cloth with the smaller openings failed as a result of filter clogging, pore-pressure buildup, and bank sloughing. The revetment on filter cloth with the larger mesh openings survived waves 3 to 4 feet high. In 1970, the Louisiana Department of Highways built a 3-mile-long Gobi-block revetment, with a 1 on 3 slope, on the type of filter cloth that had proved successful. This revetment, designed to protect an endangered reach of coast highway, survived 3 years with little damage; in 1973, however, hurricane waves damaged about 10 percent of the structure. In 1976, the revetment was rebuilt, with some alterations, and extended 1 mile; this 4-mile project survived nearly 3 years before being damaged by high waves and overtopping by a tropical storm in September 1979, while being monitored under the demonstration program. Most of the damage was initiated by uneven foundation settlement at the junction of the hardened highway shoulder with the graded embankment extending downslope (Fig. 3-22). This highlighted the need for subgrade uniformity in this type of revetment.

Figure 3-22. Gobi blocks displaced during a 1979 storm at Holly Beach, Louisiana, 16 April 1980.

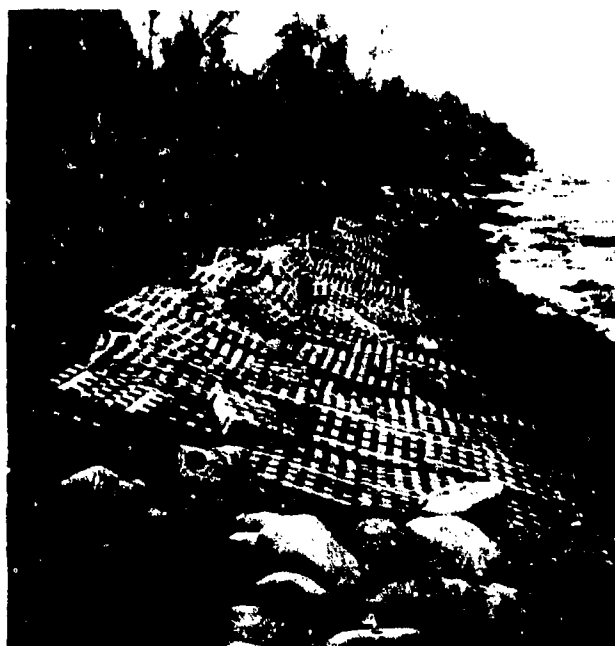
(2) Turfblocks. Turfblocks (Monoslabs) were used only at the Port Wing, Wisconsin, demonstration site in a revetment constructed in November 1978. The modules were placed over nonwoven filter cloth on a uncompacted granular fill containing large stones graded to a 1 on 3 slope. A few days after installation, the revetment was overtopped and badly damaged by storm waves on Lake Superior. After the storm, the modules were found to have been irregularly displaced and were covered with debris but not broken; the filter cloth was exposed in many places and the embankment slope was irregular, with evidence of sloughing in some areas. During the next 18 months, the revetment sustained little further damage, but displaced modules in the upper levels allowed high waves to erode the upper bank in a few places, and exposed surfaces of modules in the lower levels were severely abraded by wave-borne debris and cobbles (Fig. 3-23). Exposed areas of filter cloth had deteriorated badly. Poor subgrade preparation and possible filter cloth clogging was largely responsible for module displacement, and the abrasion due to cobble bombardment was not necessarily the result of defective concrete in the modules. Therefore, this one demonstration was not considered a fair test of the Turfblock revetment system. With proper installation in a less severe environment, there appears to be no reason why the system should not perform about as well as Jumbo blocks.

Figure 3-23. Displacement of Turfblocks,
Port Wing, Wisconsin, 7 May
1979.

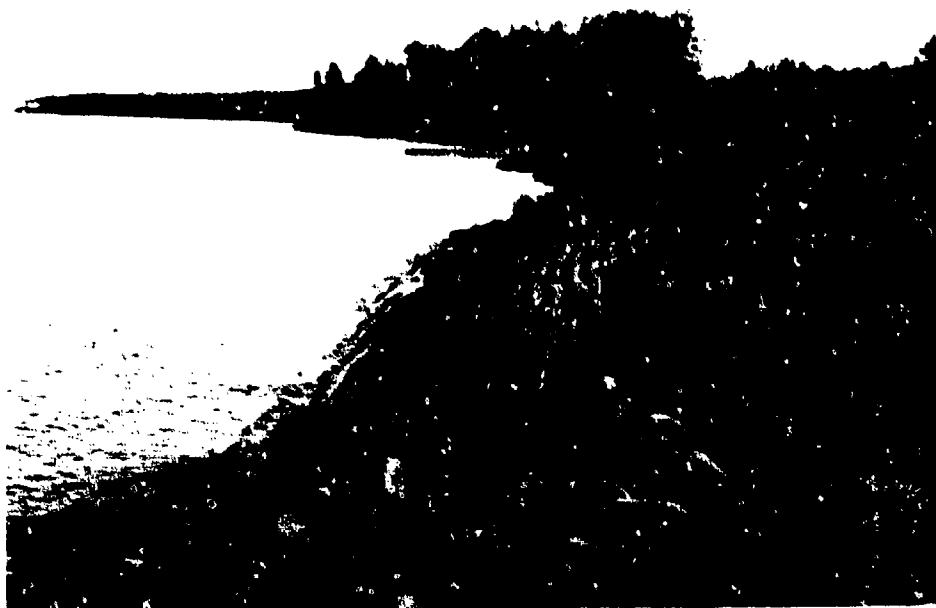
interlock. The control-block revetment was constructed in October 1978 of blocks laid on nonwoven filter cloth with their long axes parallel to the shoreline. The blocks settled irregularly on the uncompacted fill, probably because of the large stones it contained, and rows of blocks were misaligned after the November 1978 storm that also damaged the Turfblock revetment. Because of their greater thickness and the interlocks, however, they were less susceptible to overtuning by waves. Revetments of both block widths remained essentially intact during the next 18 months and continued to protect the upper bank (Fig. 3-24). Apparently, the width of the block did not affect its performance. As with the Turfblocks, however, exposed control blocks in the lower levels were severely abraded.

Figure 3-24. The control blocks holding very well at Port Wing, Wisconsin, 16 August 1979.

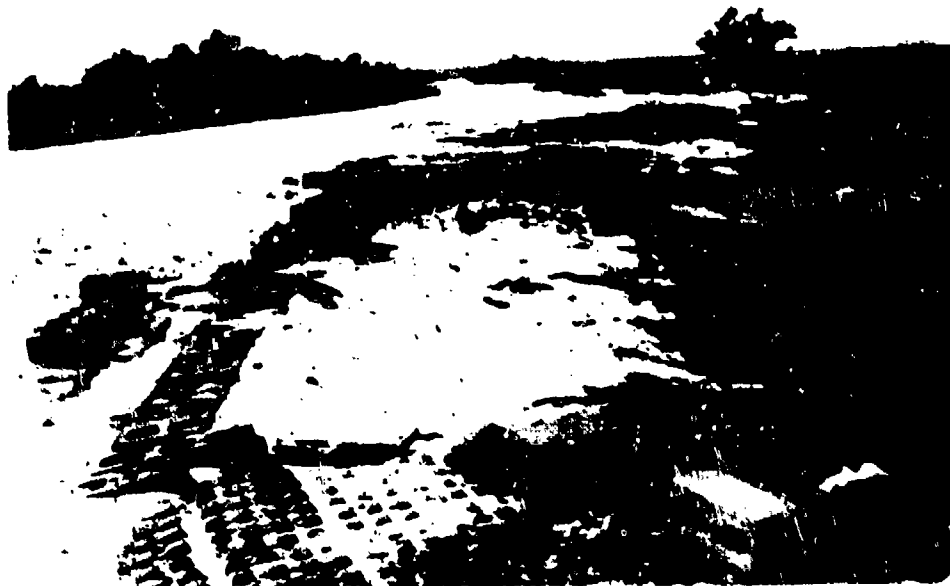
Figure 3-26. Most of the replacement blocks, mistakenly placed parallel to shoreline, were displaced during April storm, Fontainebleau, Louisiana, 12 June 1980.

perpendicular to the shoreline, and (2) that they should not be used in areas where their theft seems likely. Although they appeared to be less stable than control blocks, cost and availability are factors that may affect the choice of module type. Both types are thicker and blockier than Gobi blocks and Turfblocks, and therefore should be more stable in a revetment.

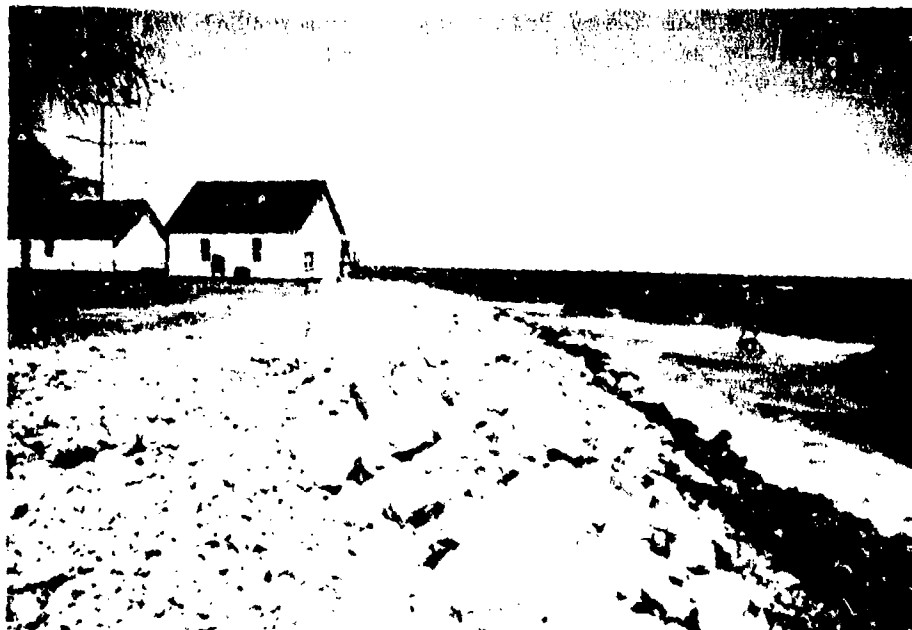
Tawas Point, armored with 100-pound stone, lies on a 1 on 3 slope with an underlayer of 4- to 10-inch stone acting as a filter. A control section tested the effect of omitting armor stone in the upper part of the revetment, which is subjected only to wave uprush. The entire structure, including the control section, survived storm waves that were reported to have breaking wave heights of up to 8 feet (although it is questionable whether they broke directly on the structure). There was no apparent damage to the structure nor to the bluff behind it (Fig. 3-30).

Figure 3-30. The stone riprap holding very well at Tawas Point, Michigan, 16 April 1980.

Continued monitoring of the Tawas Point and reconstructed Folly beach revetments is needed to assess their adequacy under more prolonged subjection to their particular wave environments.

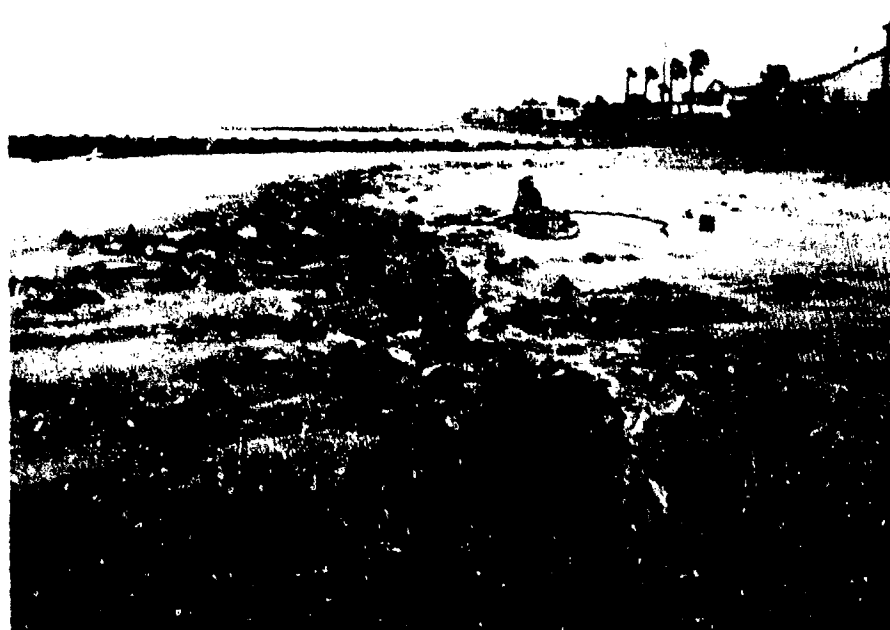
At Folly Beach, five stone riprap revetments were laid on 1 on 2 graded slopes. Each was constructed of "two-man" stone (about 100 to 200 pounds) in a layer two stones thick, placed on Polyfilter-X filter cloth. The revetments sustained little damage from normal wave action, although some stones were displaced and the filter cloth was exposed. However, each of these five revetments was destroyed by Hurricane David (Fig. 3-31). Stones in the 350-foot revetment in area 4 were not widely dispersed by the hurricane waves, as were the stones in the other revetments. This was because the high, steep bluff behind the revetment prevented the waves from carrying the stones over the top of the structure, and they fell back down the slope, protecting the bluff toe but exposing the upper bluff face.

Figure 3-31. Destruction of riprap revetment at Folly Beach, South Carolina, 15 September 1979.

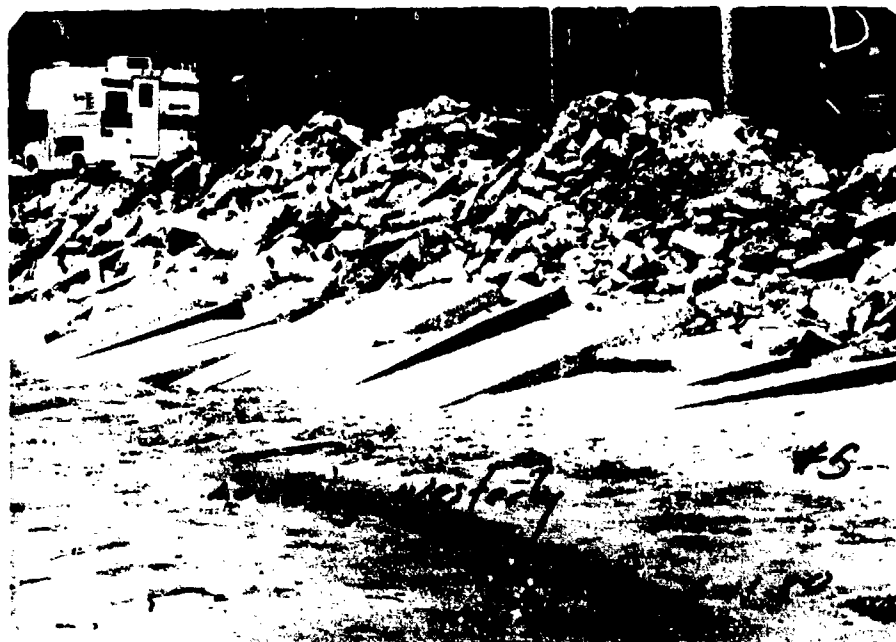
d. Concrete Slabs. This type of revetment was demonstrated at only one site--Alameda, California. The large slabs, 15 feet long, were laid against a 60° slope covered with a sheet of Mirafi-140 filter cloth. The toe was entrenched about 2 feet into the beach sand. Wave action overtopped the revetment repeatedly, saturating the sand slope and washing out the backfill. Within a few months all 12 slabs were lying almost flat on the beach (Fig. 3-32). No attempt was made to restore the section.

To be effective, a revetment should be flexible, so that it will conform to irregularities of the slope on which it is placed. The slabs in this revetment were too large and tended to bridge over the depressions that developed under them. Also, the slope was far too steep and the slabs did not transmit enough weight to the underlying soil to hold it down and provide a stable armor layer. Hydrostatic pressures lifted and tilted the slabs as the supporting materials gave way. The slabs were eventually displaced down onto the beach. Concrete slope paving, properly designed, is an excellent protection device. Proper slope, weep holes, toe embedment, etc., are necessary and vital considerations. However, the Alameda concrete-slab revetment was not properly designed and therefore failed.

Figure 3-32. The concrete slabs lying almost flat on the beach, Alameda, California, 11 April 1980.

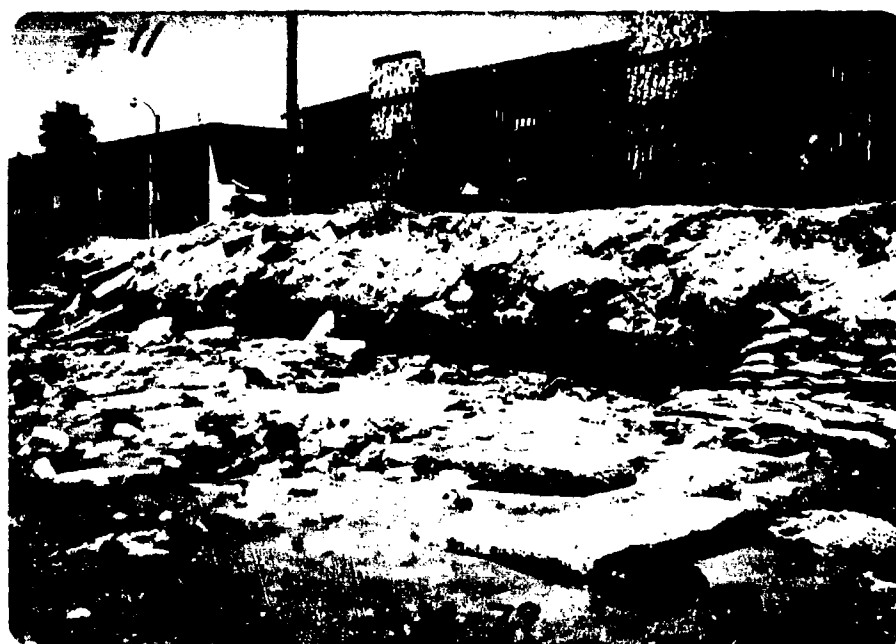
Device 11 was installed about 100 feet downdrift of the device 8 perched beach at Alameda. The sill surrounding and retaining the device 8 beachfill acted as a groin, preventing littoral nourishment from reaching the device 11 area. As a result, the beach fronting device 11 became progressively lower with time. Within a few months, the toe was undercut and the lower tiers of bags slid downward, exposing gaps of unprotected embankment farther up the slope. Also, it was noted that the closure twine in many of the bags had broken, allowing sand to spill out and cause collapse of these bags. Wave action during high tides then removed the embankment material from behind the bags, hastening the collapse of the entire structure. The erosion seemed to occur both at the toe and along the top of the embankment. As the Sand Pillows slid, erosion of the embankment increased. After about 6 months, all of the bags were down on the beach, and most were empty (Fig. 3-33). The bag fabric had not deteriorated.

Figure 3-33. Device 11 (left) failed completely, and subsequent erosion of the bank occurred, Alameda, California, 18 July 1979.

(b) The single-bag thickness of the revetment was inadequate. When any one bag moved out of place, the embankment became exposed to erosive forces that could progressively destroy the entire structure.

(c) Sand-cement fill provides some degree of structural safety with sandbag construction. However, if filled only with sand, a nondegrading fabric such as the acrylic material in the Sand Pillows should be used, and closure twine should be sufficiently strong and durable to make the bag closure as secure as the fabric material itself.

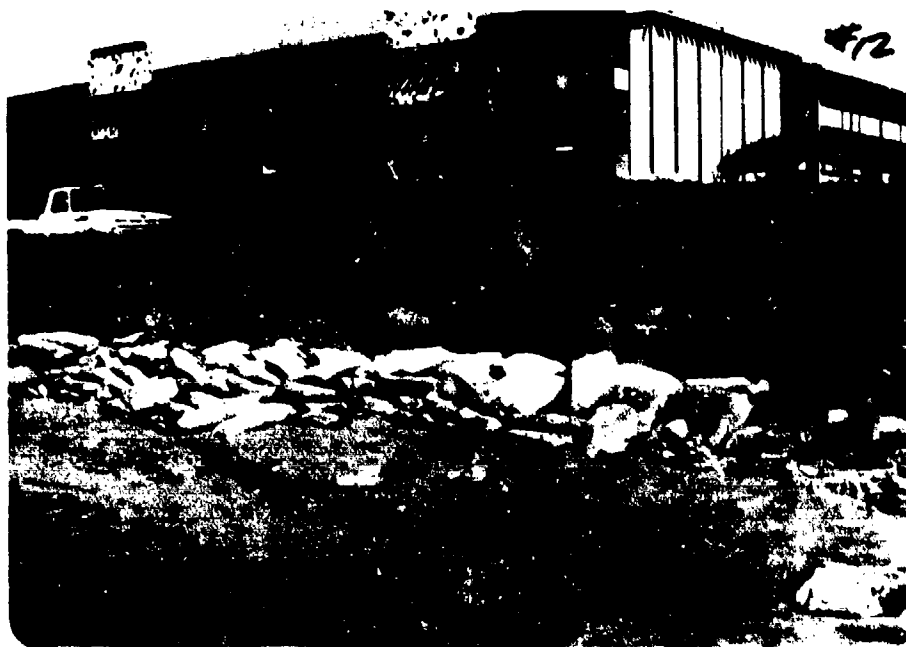
(2) Device 12. This revetment was identical to device 11 except that the Sand Pillows were filled with a lean (8-to-1) sand-cement mixture. As a result, the Sand-Pillow modules generally held their shape (although some did crack), but toe scour and bank erosion behind the modules eventually rendered the revetment ineffective. Within 1 year, all of the modules were in a windrow on the beach, and erosion of the embankment behind them continued virtually unabated, although the modules on the beach did absorb a small amount of wave energy (Fig. 3-34).

Figure 3-34. Sand-Pillow revetment of device 12 in a wind-row while erosion of embankment continued, Alameda, California, 7 February 1980.

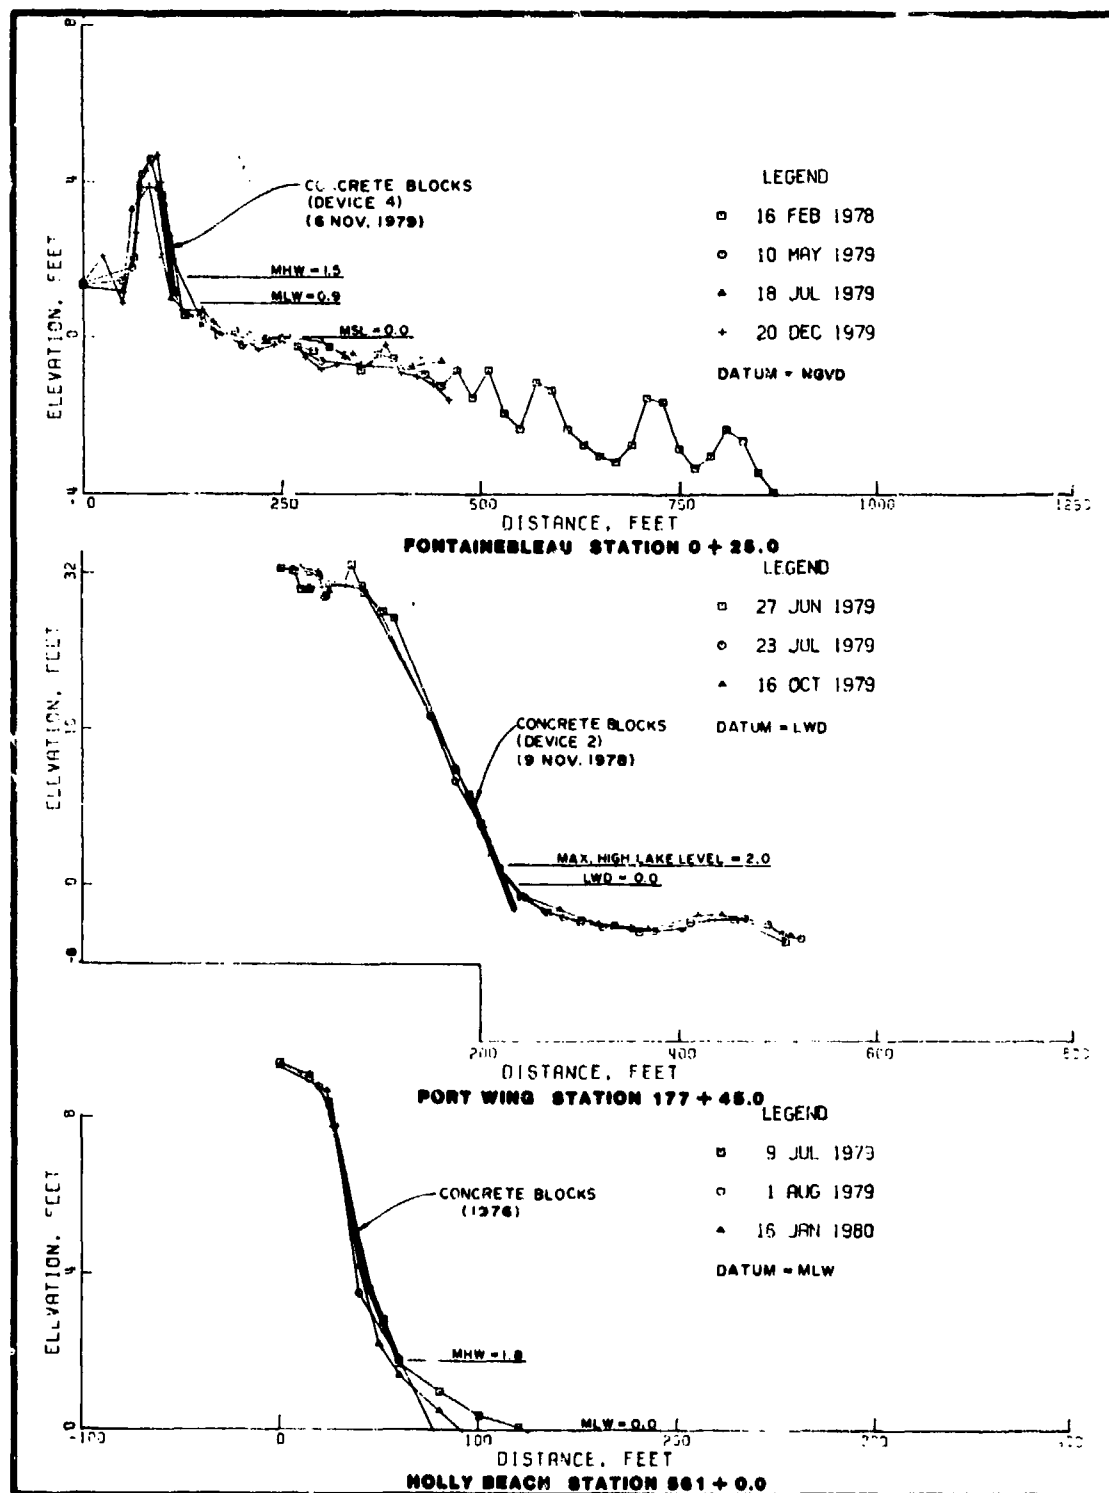
Figure 3-42. Profiles of concrete-block revetments.

Comparative profiles of similar devices were included in Section III. Profiles through the concrete block revetment are shown in Figure 3-42. Shoreline erosion of 10 to 15 feet is indicated by a comparison of the 9 July 1979 with the 16 January 1980 profiles.

(1) Concrete Blocks. Profiles of concrete-block revetments were compared at three sites: Fontainebleau, Louisiana; Port Wing, Wisconsin; and Holly Beach, Louisiana (Fig. 3-42).

At Fontainebleau the profiles are at device 3, a revetment of standard construction blocks. The structure was damaged by vandalism and problems were encountered with displacement of blocks with their long axes placed parallel

to the shoreline. This structure was completed in November 1979. Only one survey was made after the completion of the revetment, thus, the profiles do not give any information as to the effectiveness of the structure in retaining the beach.

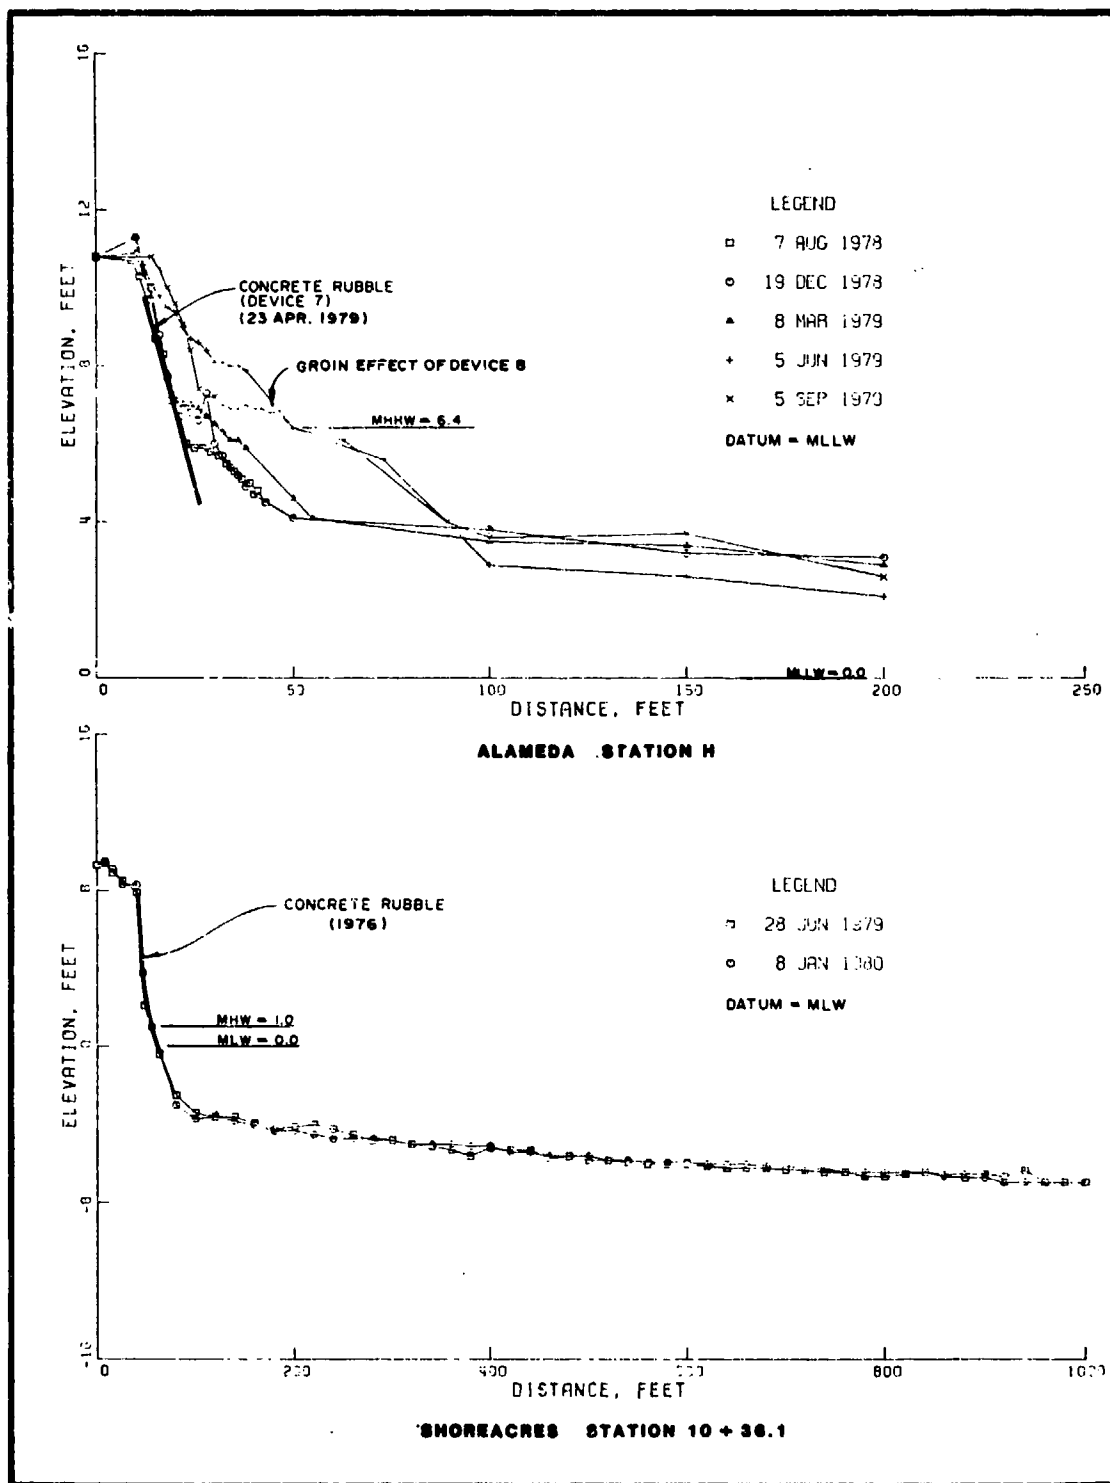
(2) Concrete Rubble. Profile analysis was done to compare concrete-rubble revetments at two sites--Shoreacres, Texas, and Alameda, California. These profiles are shown in Figure 3-43.

The concrete-rubble revetment (device 7) at Alameda survived the monitoring period without much structural damage, but this is attributed to the fact that the structure was protected by a fillet of sand trapped in the lee of a sandbag sill. The profiles show the accretion in front of the revetment which protected it from damage. Other concrete-rubble revetments which were exposed to wave action were destroyed at Alameda. Therefore, the Shoreacres revetment was a more effective device in protecting the beach; however, this effectiveness is site-sensitive.

Figure 3-43. Profiles of concrete-rubble revetments.

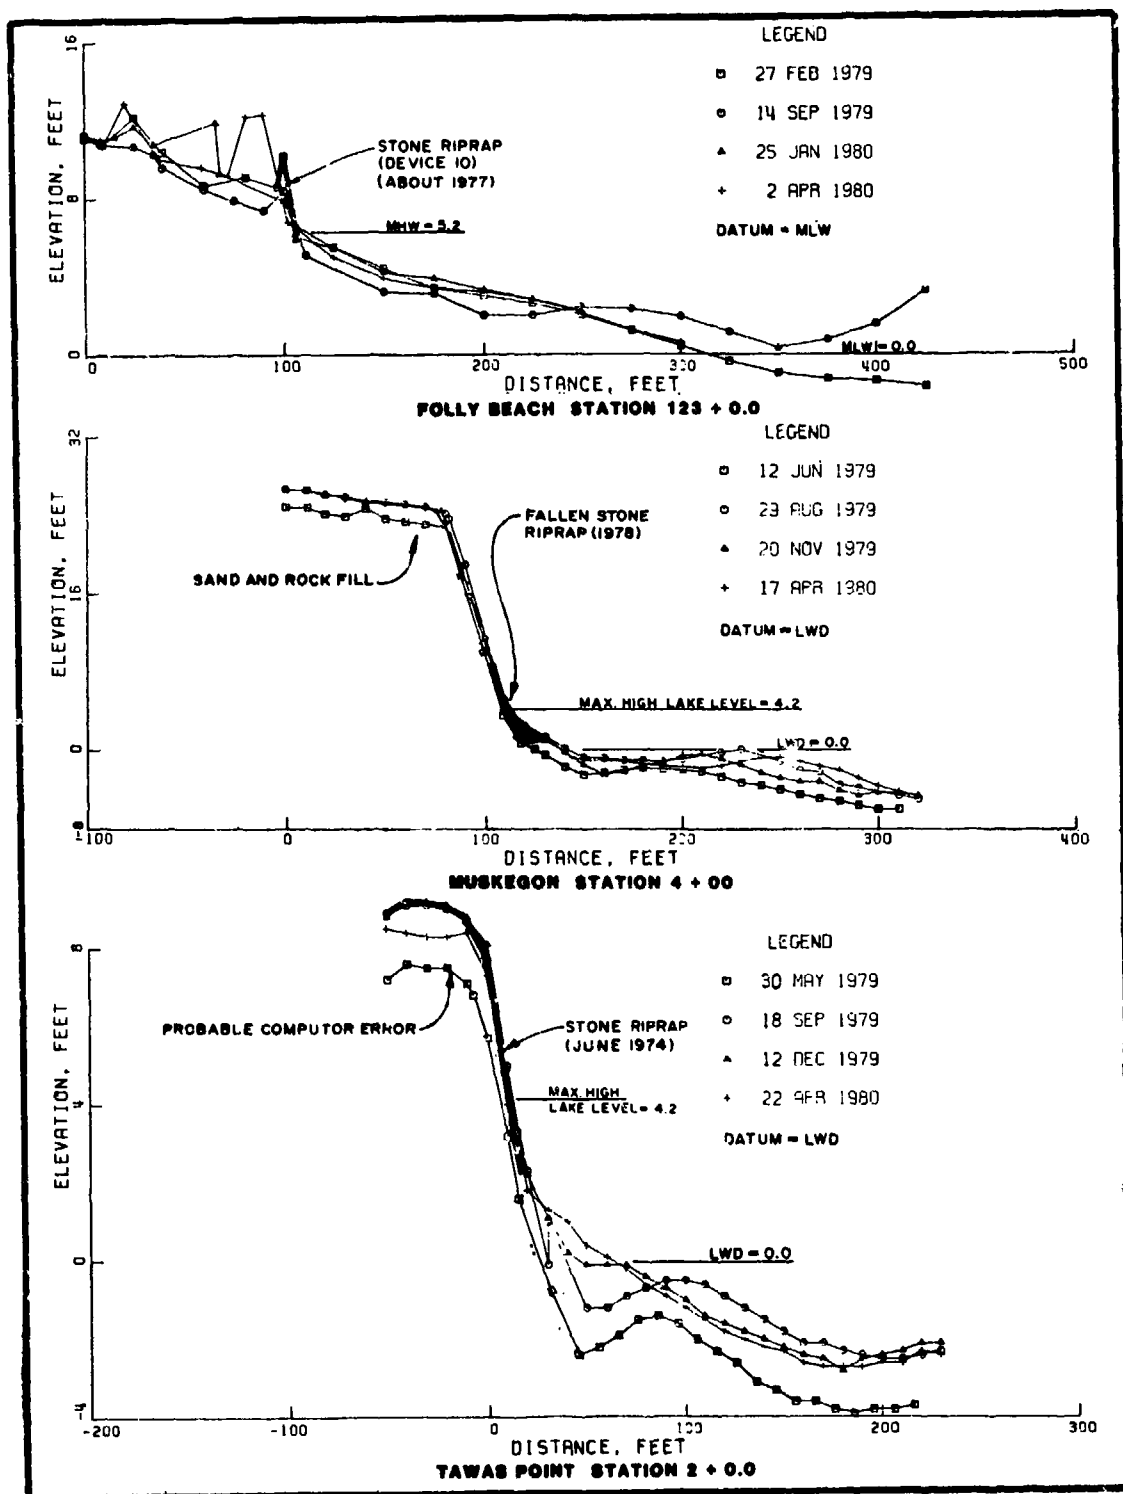
(3) Stone Riprap. Profile analysis was done to compare stone-rubble revetments at Folly Beach, South Carolina; Muskegon, Michigan; and Tawas Point, Michigan. The profiles are shown in Figure 3-44.

The Muskegon rubble was not a designed revetment, but was a stone layer at the foot of a beach fill which was formed by selective sorting. The result was a layer of stone rubble which covered the toe of the fill. Some erosion and slumping of the bluff occurred at this site, as shown by the profiles.

A stone-rubble revetment was monitored at Tawas Point. This structure remained structurally sound and withstood storm waves with breaking heights of

Figure 3-44. Profiles of stone-riprap revetments.

up to 8 feet. The profiles show that significant accretion was present at the structure site.

The stone-rubble revetment at Tawas Point was the most effective in preventing erosion, as the others suffered damage and allowed erosion.

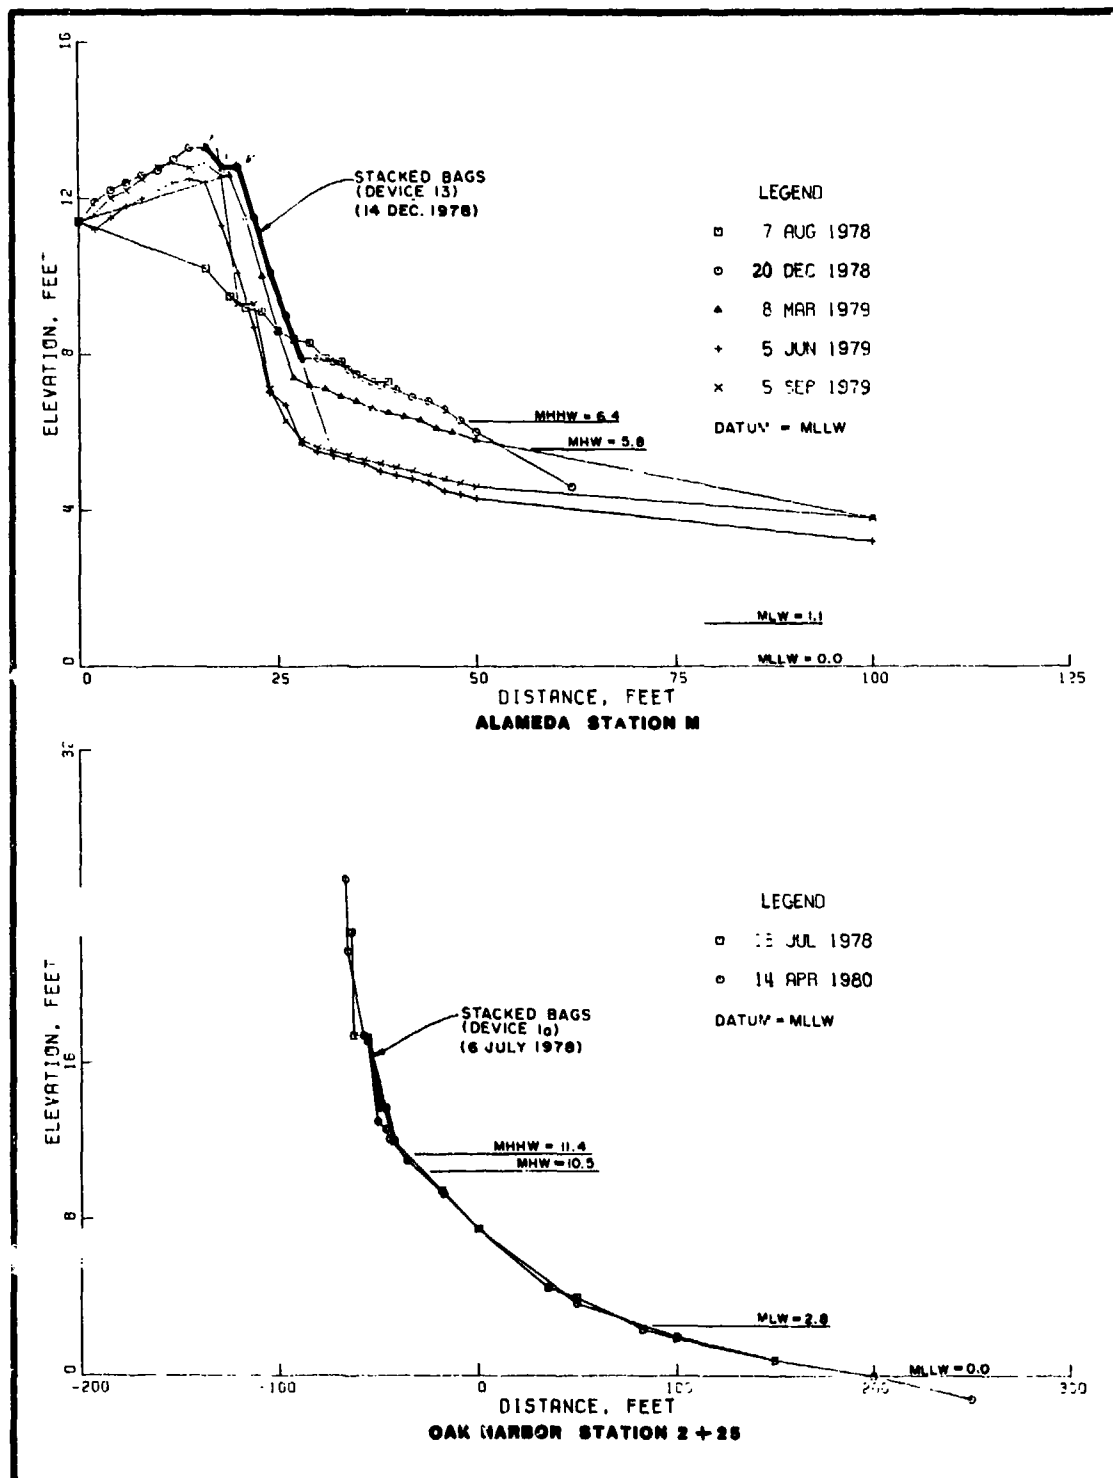
(4) Stacked Bags. Profile analyses were done to compare stacked bag revetments at Alameda, California, and Oak Harbor, Washington. Profiles are shown in Figure 3-45. A revetment of stacked bags was demonstrated at Alameda. The toe of this structure was progressively undermined and the structure eventually failed. The embankment behind the structure also suffered severe erosion. The profiles show erosion on both the beach in front of the revetment and the embankment behind it. (Note: the structure was built about 4 feet higher than the construction drawings called for.)

A revetment of stacked bags was also demonstrated at Oak Harbor. This structure, unlike Alameda, performed well, surviving wave attack with minimal damage. The revetment successfully protected the beach from eroding as shown in the profiles. This structure was clearly more effective than the Alameda revetments.

Figure 3-45. Profiles of stacked-bag revetments.

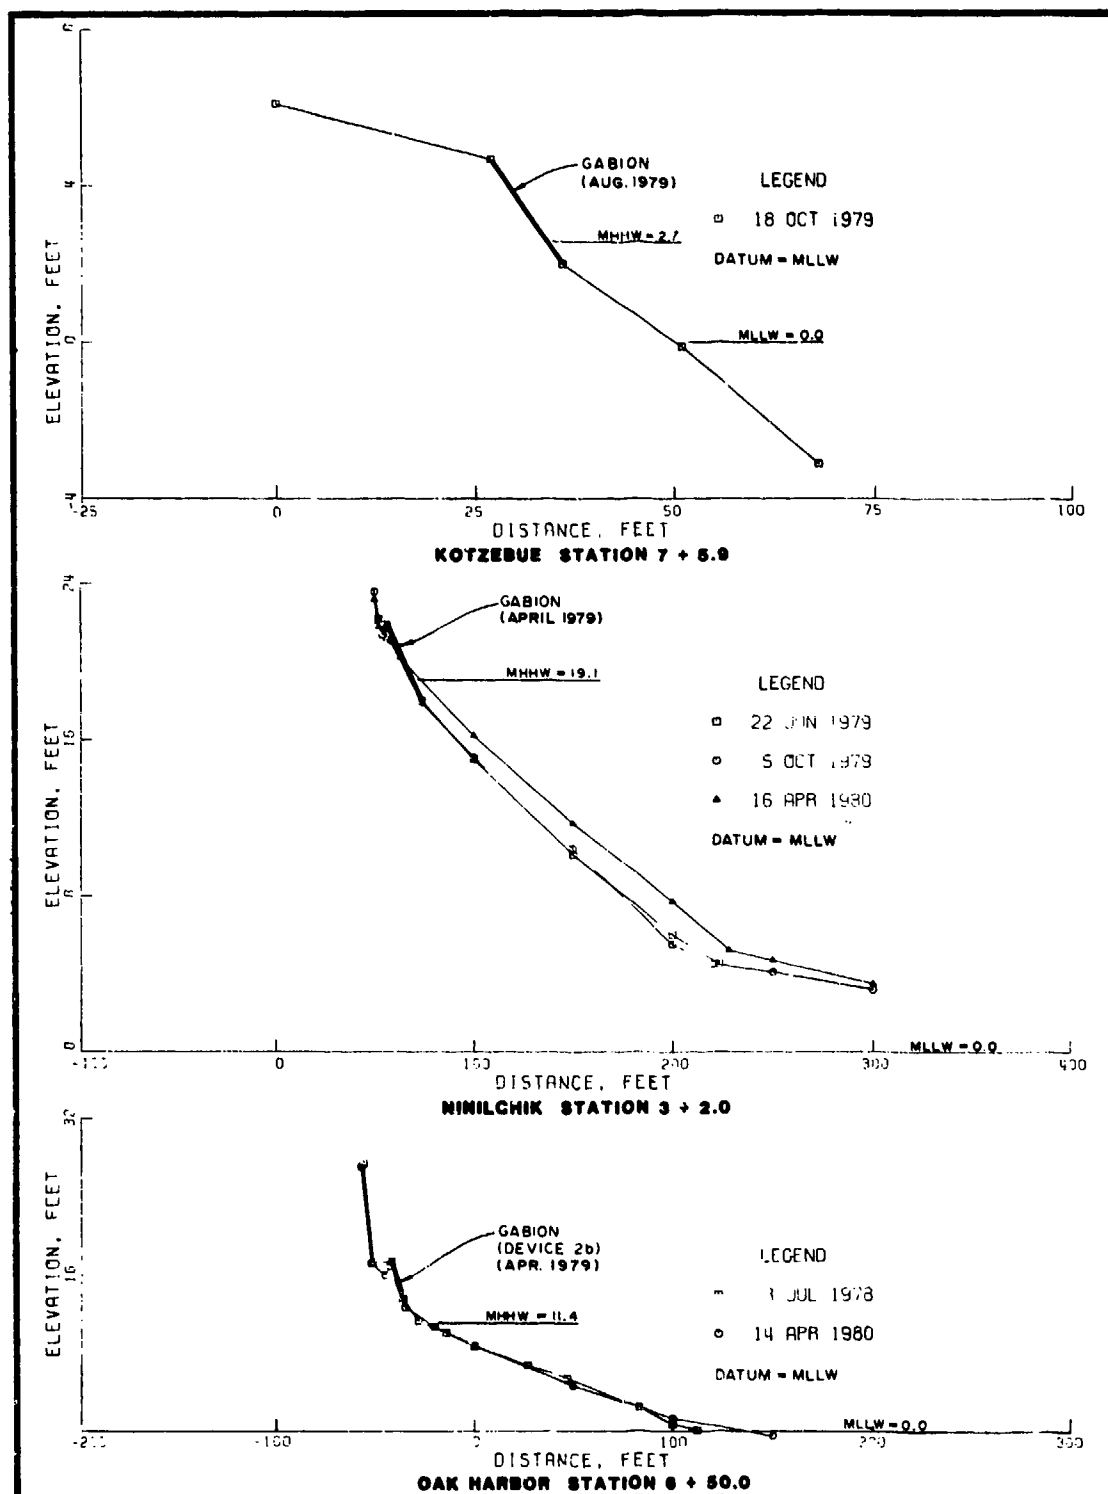
(5) Gabions. Profile analysis of gabion revetments were done at three sites--Kotzebue, Alaska; Ninilchik, Alaska; and Oak Harbor, Washington. The profiles are shown in Figure 3-46. The gabion revetment at Kotzebue suffered no structural damage to date, and the structure adequately protected the beach. The site, however, has not been surveyed since the initial time in October 1979, and thus the profiles offer no information as to the extent of erosion or accretion at the site.

The gabion revetment at Ninilchik suffered some damage in that some baskets were damaged and rocks were knocked out. Despite this damage, the structure protected the beach from erosion. The profiles show that a significant amount of accretion was present at the site. Both of these structures appear to work reasonably well, but there has not been sufficient survey data to adequately compare the two structures.

Figure 3-46. Profiles of gabion revetments.

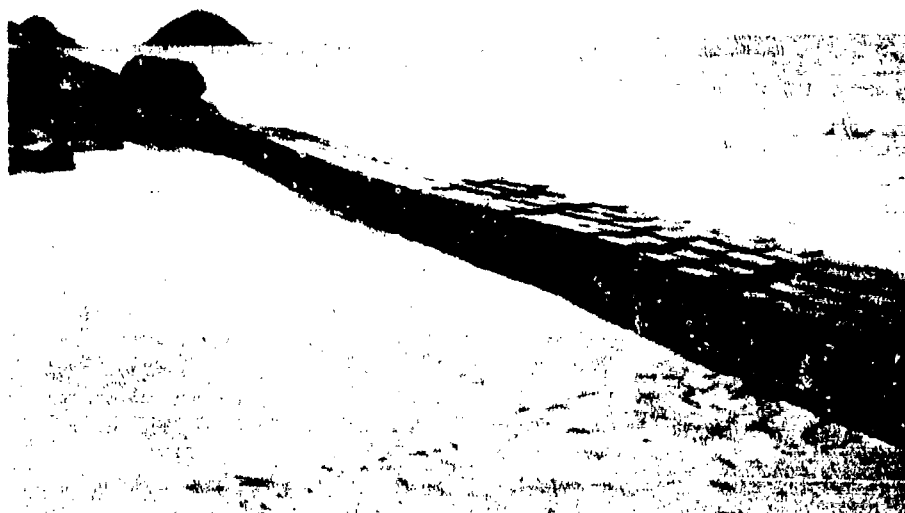
The Basin Baycu and Hawaii Sandgrabbers accumulated sand quickly (Figs. 3-68 and 3-69), while accretion was slow at Folly Beach. A number of common problems developed at each of the project sites. The first, which deals with downdrift erosion, was readily observed at the Kualoa site. To the extent that the Sandgrabber withdraws sand from the littoral budget, it deprives the downdrift beaches of their normal sand nourishment. This results in accelerated erosion downdrift of the structure, with the rate depending on the volume of sand in littoral transport and its speed in the downdrift direction. The littoral system at Kualoa was already deficient when the Sandgrabber was installed. The structure managed to halt the erosion at the site, but at the cost of excessive loss of downcoast beach (Fig. 3-70).

Figure 3-69. Sand accumulation behind Sandgrabber at Bellows Beach, Hawaii, 8 November 1979.

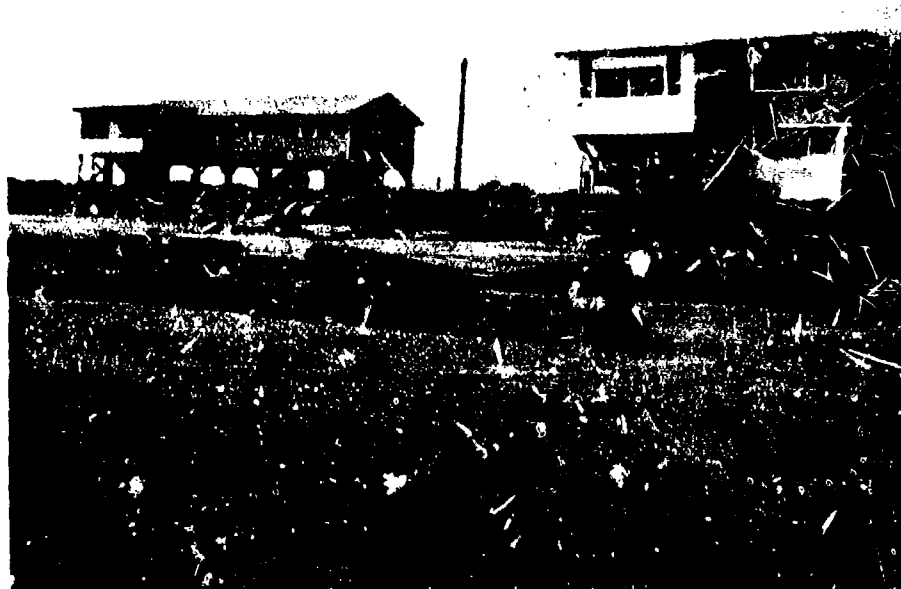
Structural degradation of the Sandgrabber usually begins with toe scour. As sand is lost, the seaward side of the structure rotates downward. If the toe scour is uniform and the structure rotates as a whole, no damage occurs. If scour is not uniform, the differential rotation from block to block results in some blocks being displaced in the section. The U-ties were designed to allow for a certain amount of differential displacement; however, as the displacement exceeds the allowable, the stress of the U-ties against the concrete cracks or breaks the blocks. As weak concrete will hasten this block breakage, compressive strength tests should be performed on each batch of blocks before construction to assure that they meet building block standards. Block breakage occurred at each of the project sites, but the damage was severe only at Folly Beach, where more than half of the blocks in the seaward row of the top tier were lost (Fig. 3-71).

Figure 3-71. The top tier of the seaward row of the Sandgrabber in area 3 lost over half of its blocks, Folly Beach, South Carolina, 5 March 1980.

Several precautions are suggested to reduce block breakage. Periodic tie-bar adjustment might help prevent breakage in zones of differential settlement. Installing the blocks in a trench excavated to the anticipated toe scour depth should prevent structure rotations. Elastic ties instead of the galvanized-steel ties might provide additional flexibility, allowing smooth transitions and conformations to grade changes. Synthetic, elastic ties of some type would also eliminate corrosion problems. Cloth or gravel filters were not tested, but properly installed under a Sandgrabber they might deter scouring and promote uniform settling. The flanking erosion at the south end of the Kualoa installation might have been prevented by gradually curving the end of the structure well back into the bank (Fig. 3-70). This would have necessitated some excavation, but it would have obviated the need for the supplemental tieback structure, which had to be added later.

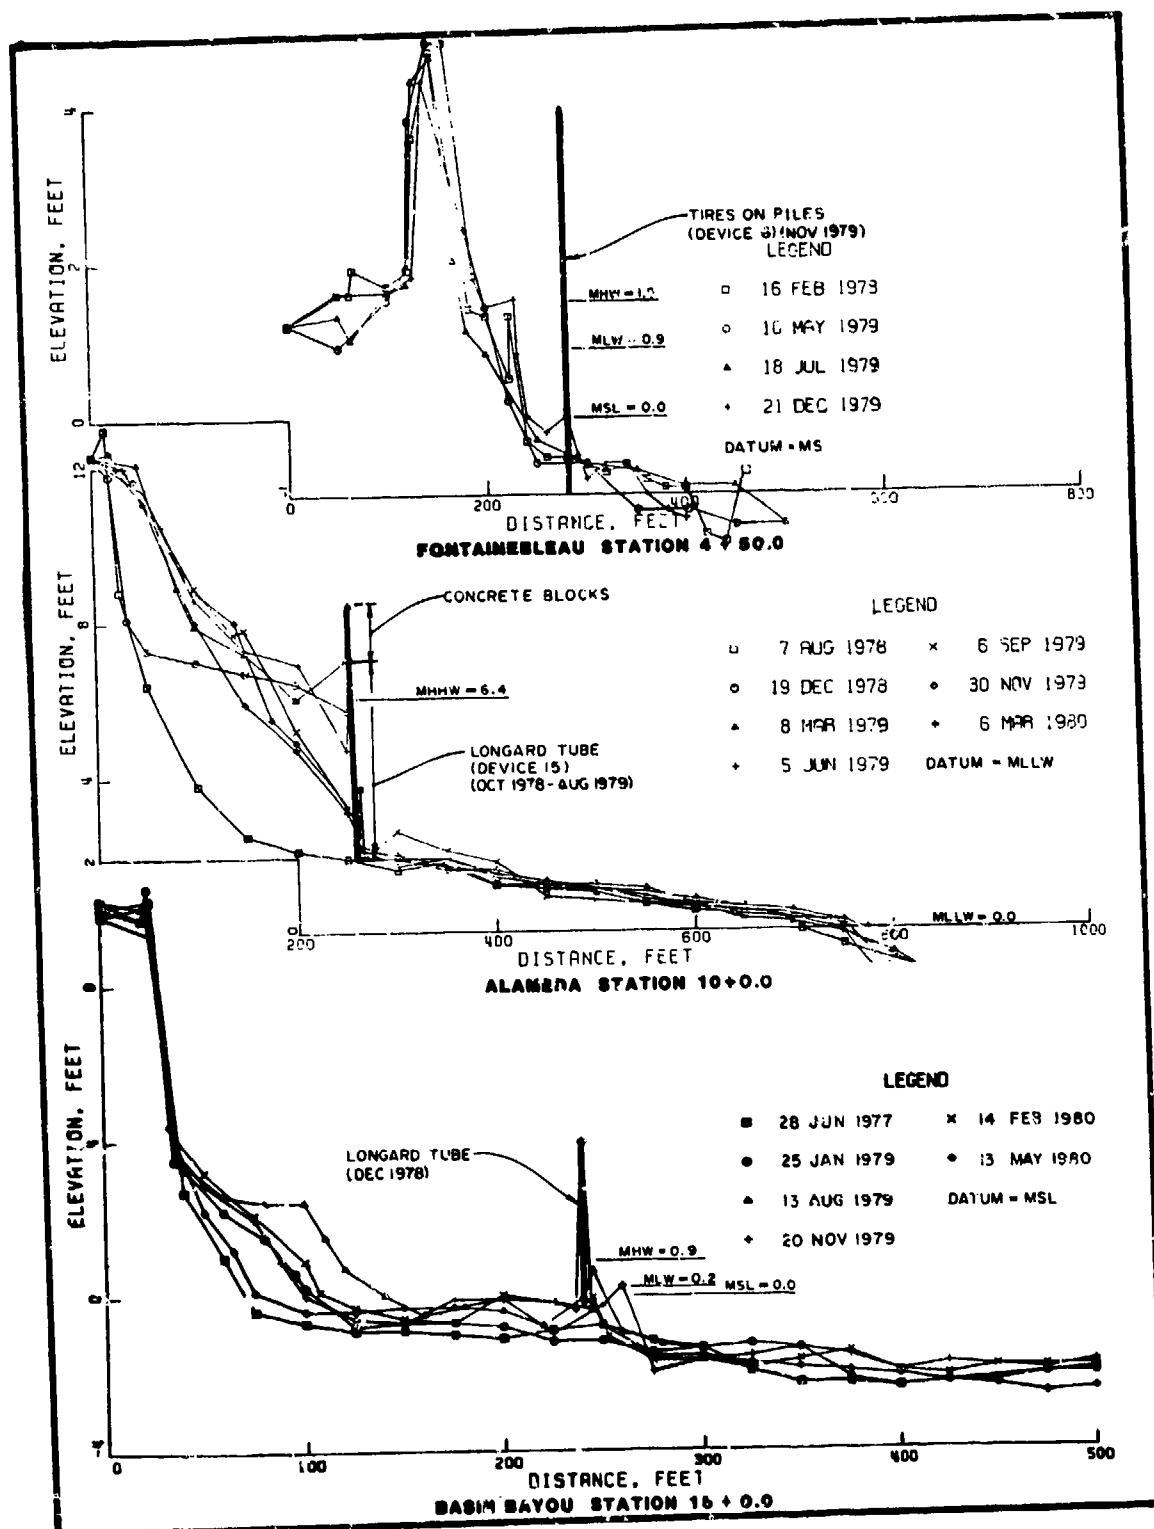
Figure 3-75. Profiles of tires on piles and Longard-tube breakwaters.

(1) Tires on Piles and Longard Tubes. Profile analyses of these structures were done at Fontainebleau, Louisiana; Alameda, California; and Basin Bayou, Florida. These profiles are shown in Figure 3-75.

At Fontainebleau State Park, Louisiana, a breakwater was constructed of closely spaced timber piles driven into the lake bottom with tires stacked 4 feet high on each pile. This device adequately attenuated waves, and performed without any structural deterioration. The profiles at this site are somewhat erratic, but they show some accretion in lee of the structure.

A Longard-tube breakwater was demonstrated at Alameda, California. This structure was damaged by vandals and eventually could no longer retain the manmade sand tombolo that had been placed in its lee. Construction of this structure was completed in October 1978. The profiles show accretion in lee of the breakwater while the structure was intact, from December 1978 to June 1979. After June 1979, corresponding with the degradation of the structure, erosion of the tombolo continued through the remainder of the monitoring period.

Another Longard-tube breakwater was demonstrated at Basin Bayou, Florida. This structure was also damaged by vandals, although not as badly as at Alameda. This damage halted the formation of a tombolo which had been formerly in the breakwater's lee. The profiles for this site show that progressive accretion was evident just behind the structure. On the beach, however, the trend was more erratic with accretion from August 1977 through August 1979 followed by erosion thereafter. A new Longard tube was placed at the site in May 1980, but as this was the end of the monitoring period its effectiveness cannot be determined. Because Longard tubes are susceptible to damage by vandals (which seems to be unavoidable), the stacked tire on pole breakwater appears to be a more effective device in protecting the beach from erosion. Longard tubes work well, but once damaged their lifetime is greatly reduced.
